TECHNICAL INSPECTION REPORT
CONFIDENTIAL

U.S. S. SALT LAKE CITY (CCA 25)

VOLUME 2 OF 2

OPERATION CROSSROADS

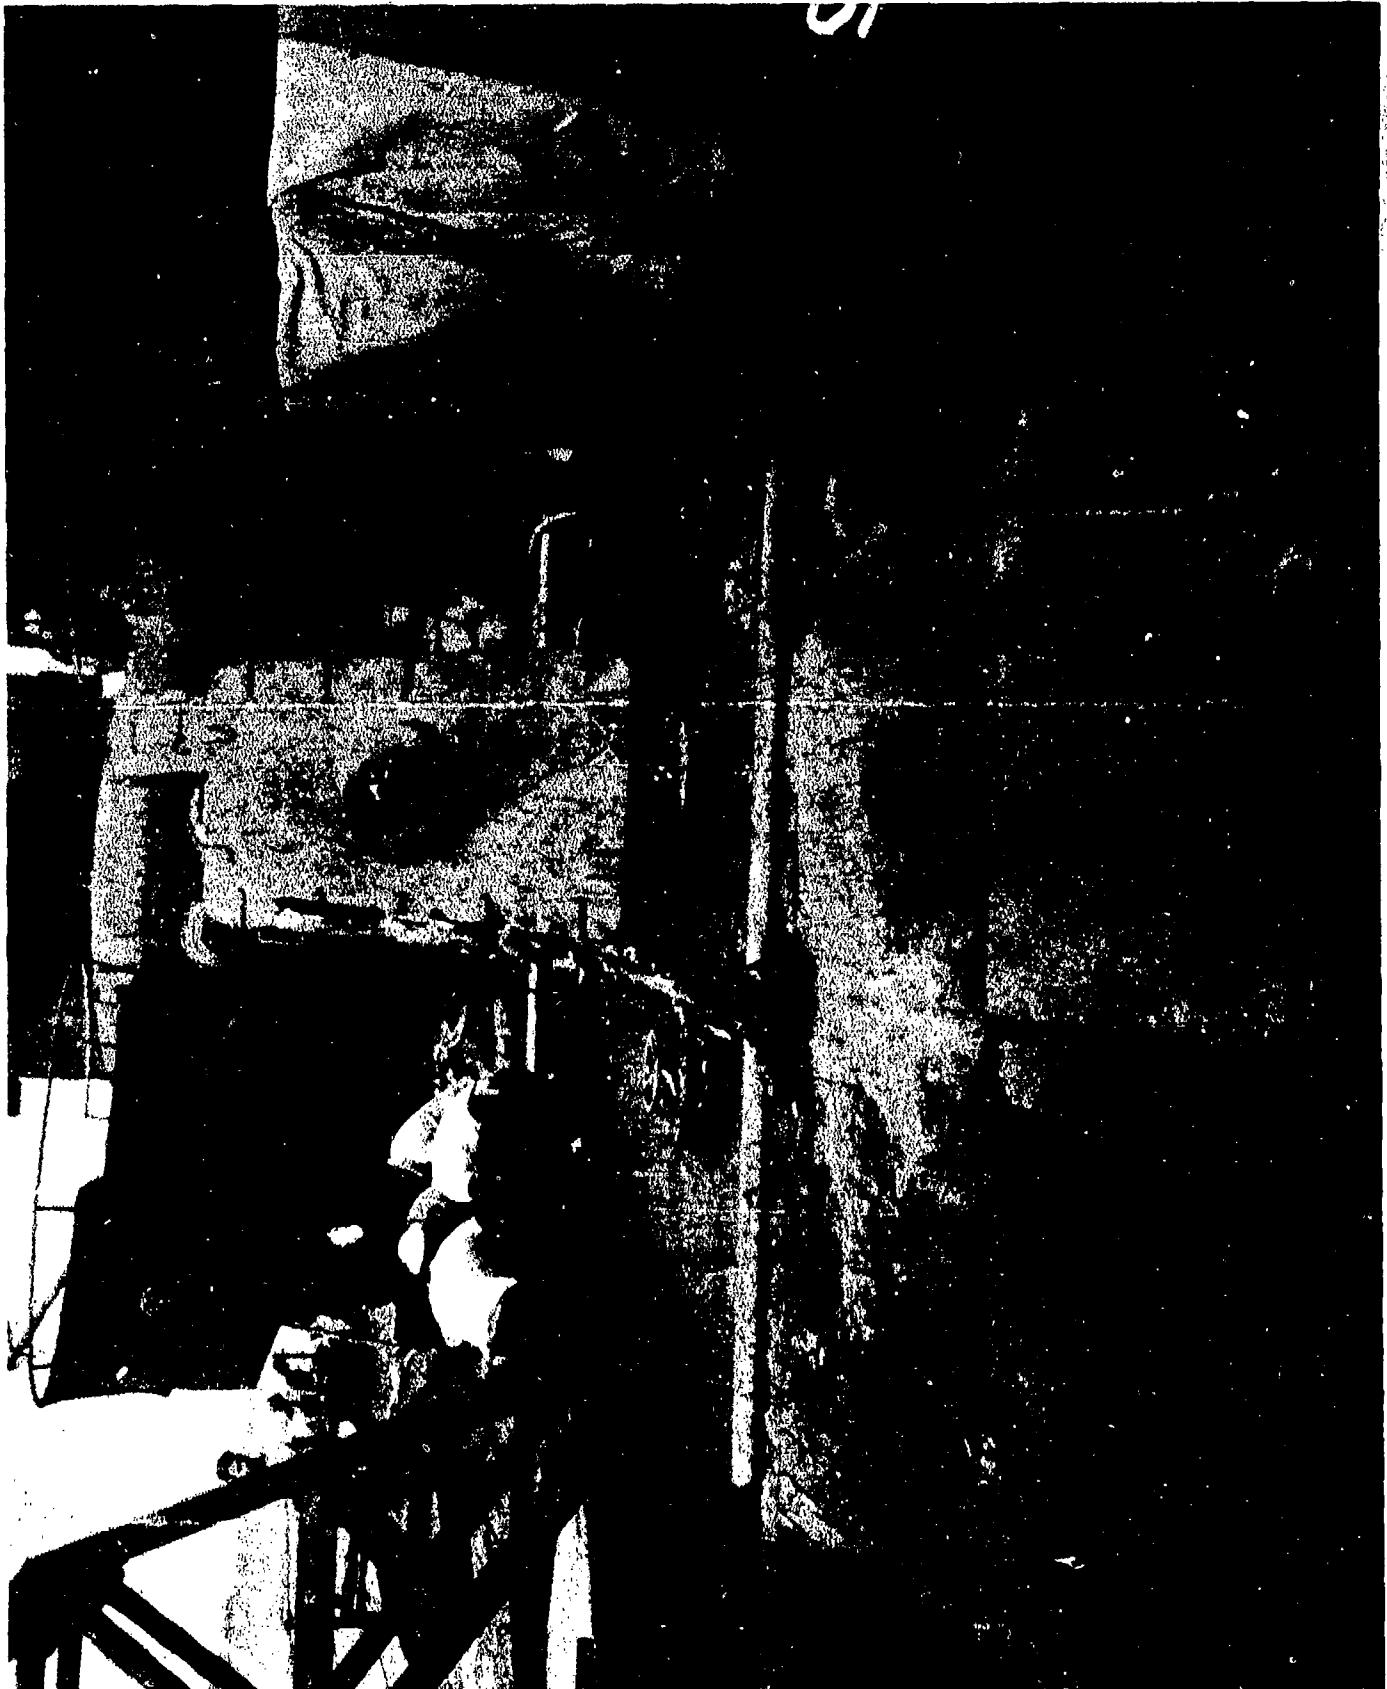
AA-CR-88-2085-10. Looking forward on centerline from astern. Showing deflection of deck.

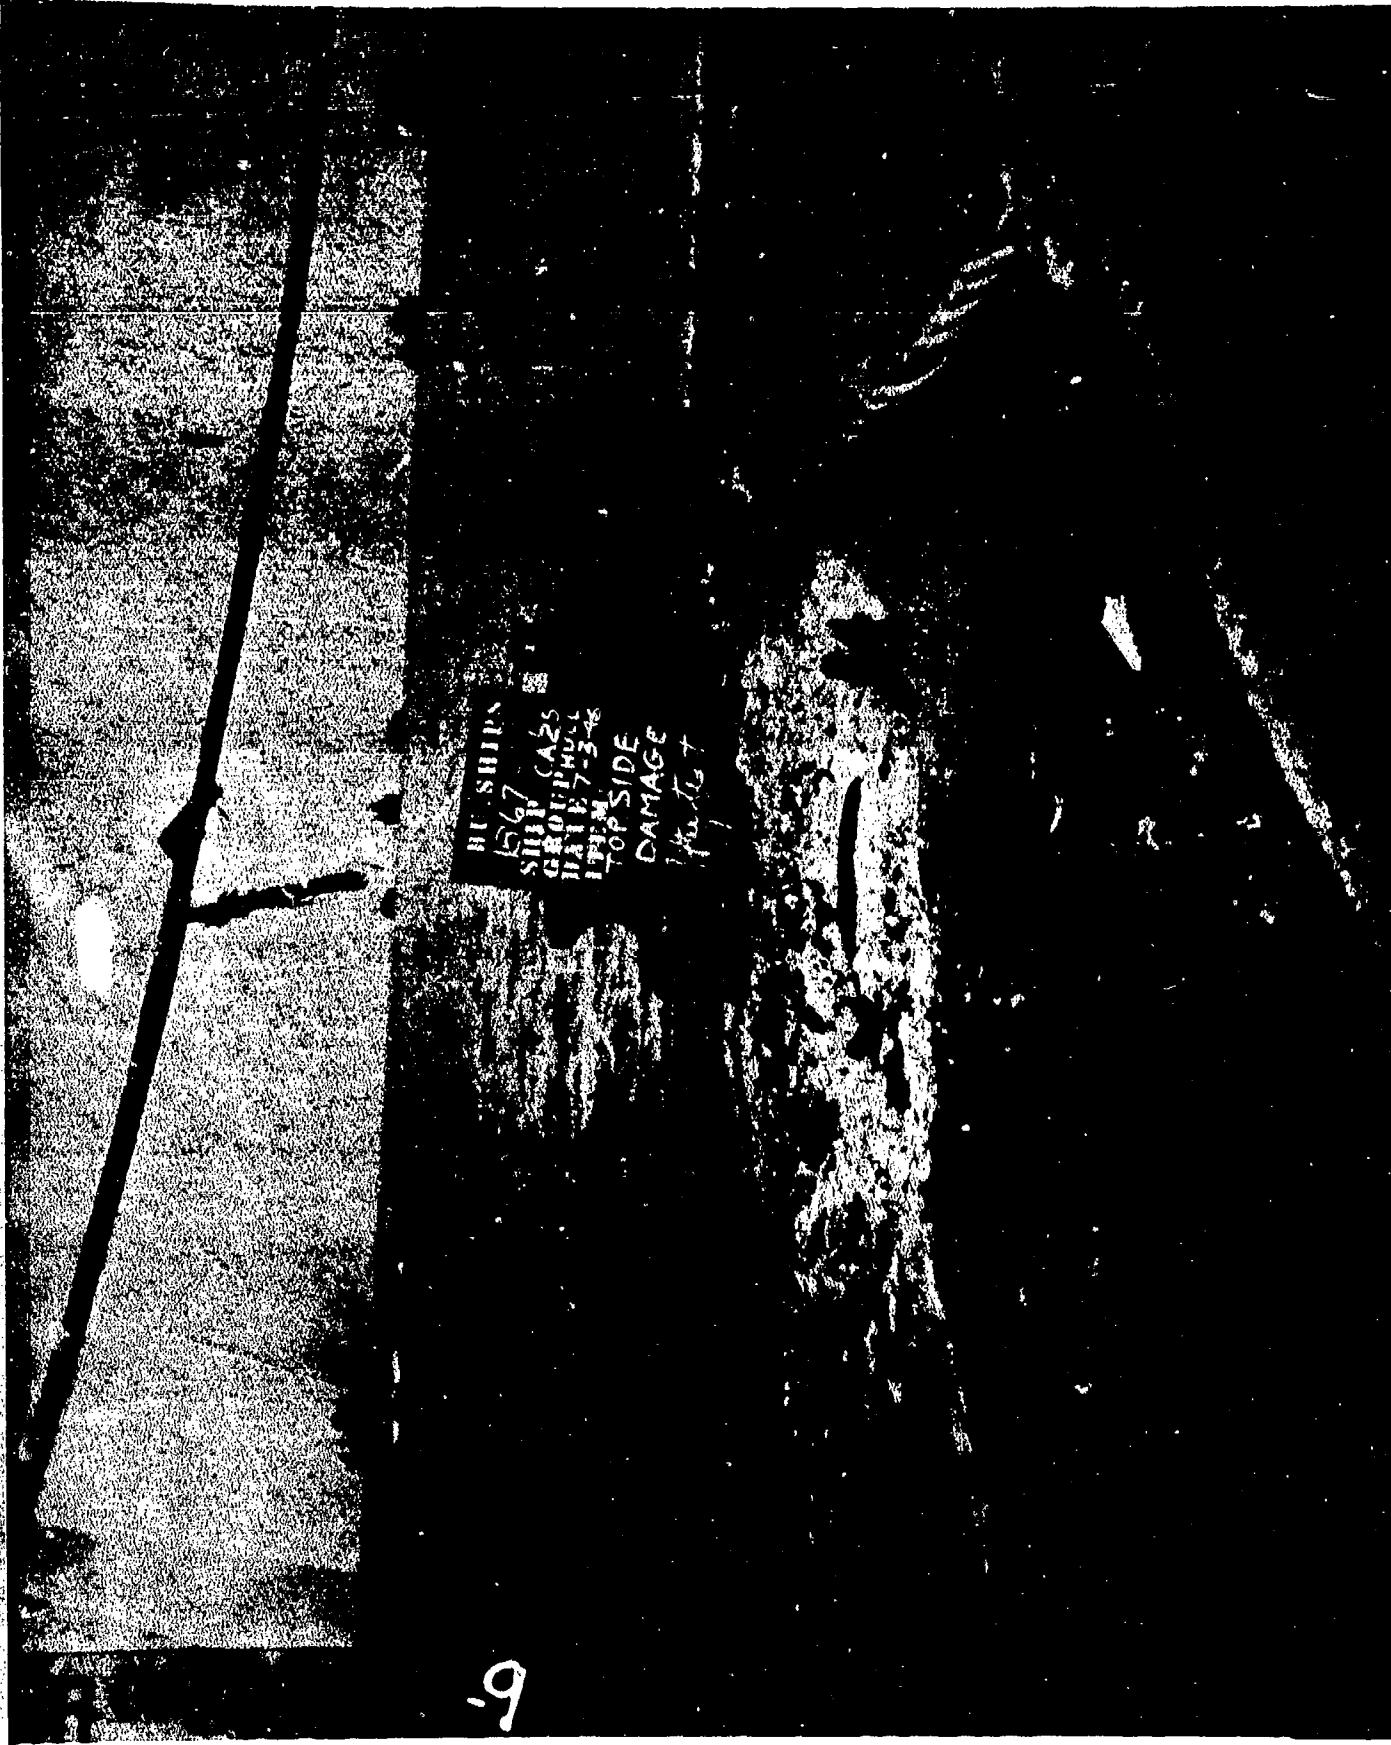
AA-CR-62-1867-9. Thrum mat around same cable as in 1867-7, main deck at stern. Mat and wood deck burned. Cable burned and parted.

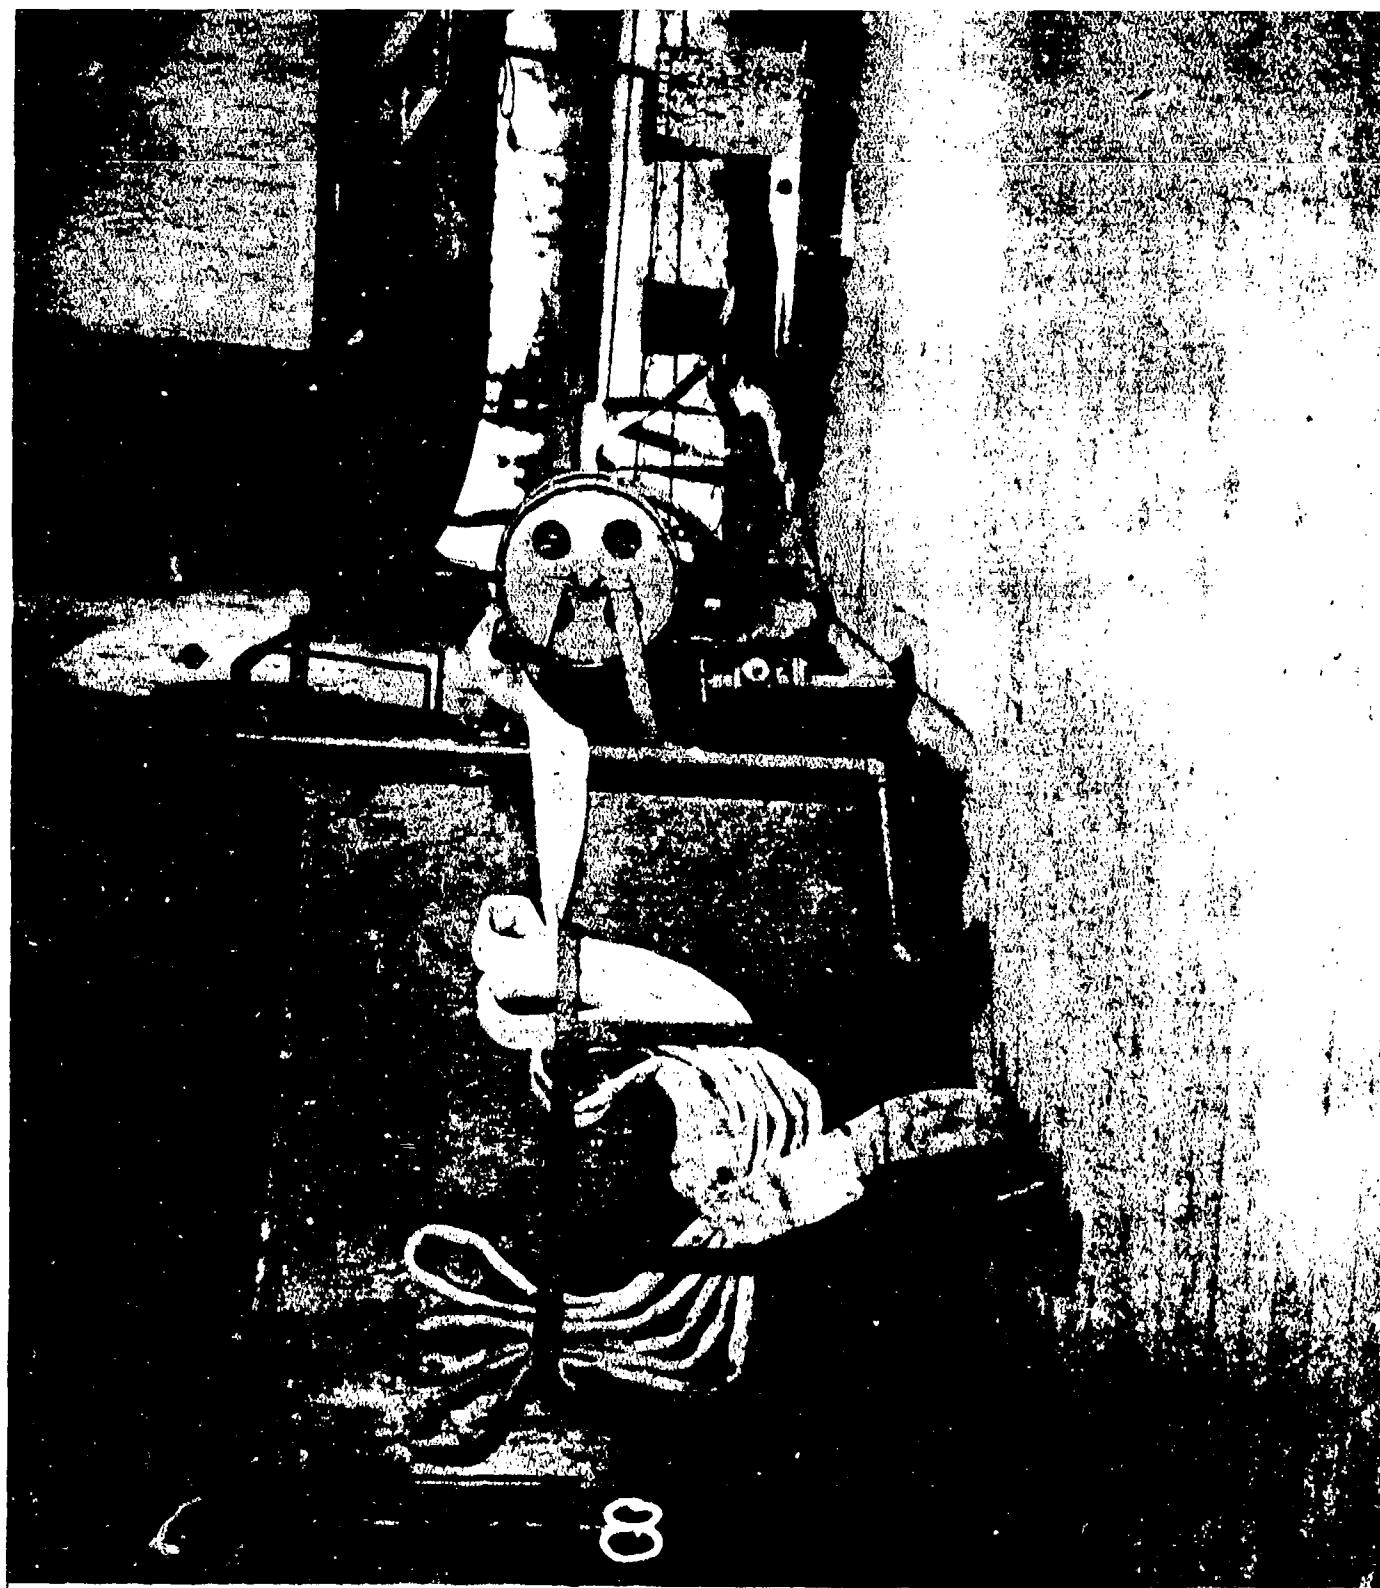
AA-CR-62-1861-8. Looking to port at frame 28 starboard. Showing firehose blown from rack and across deck to port.

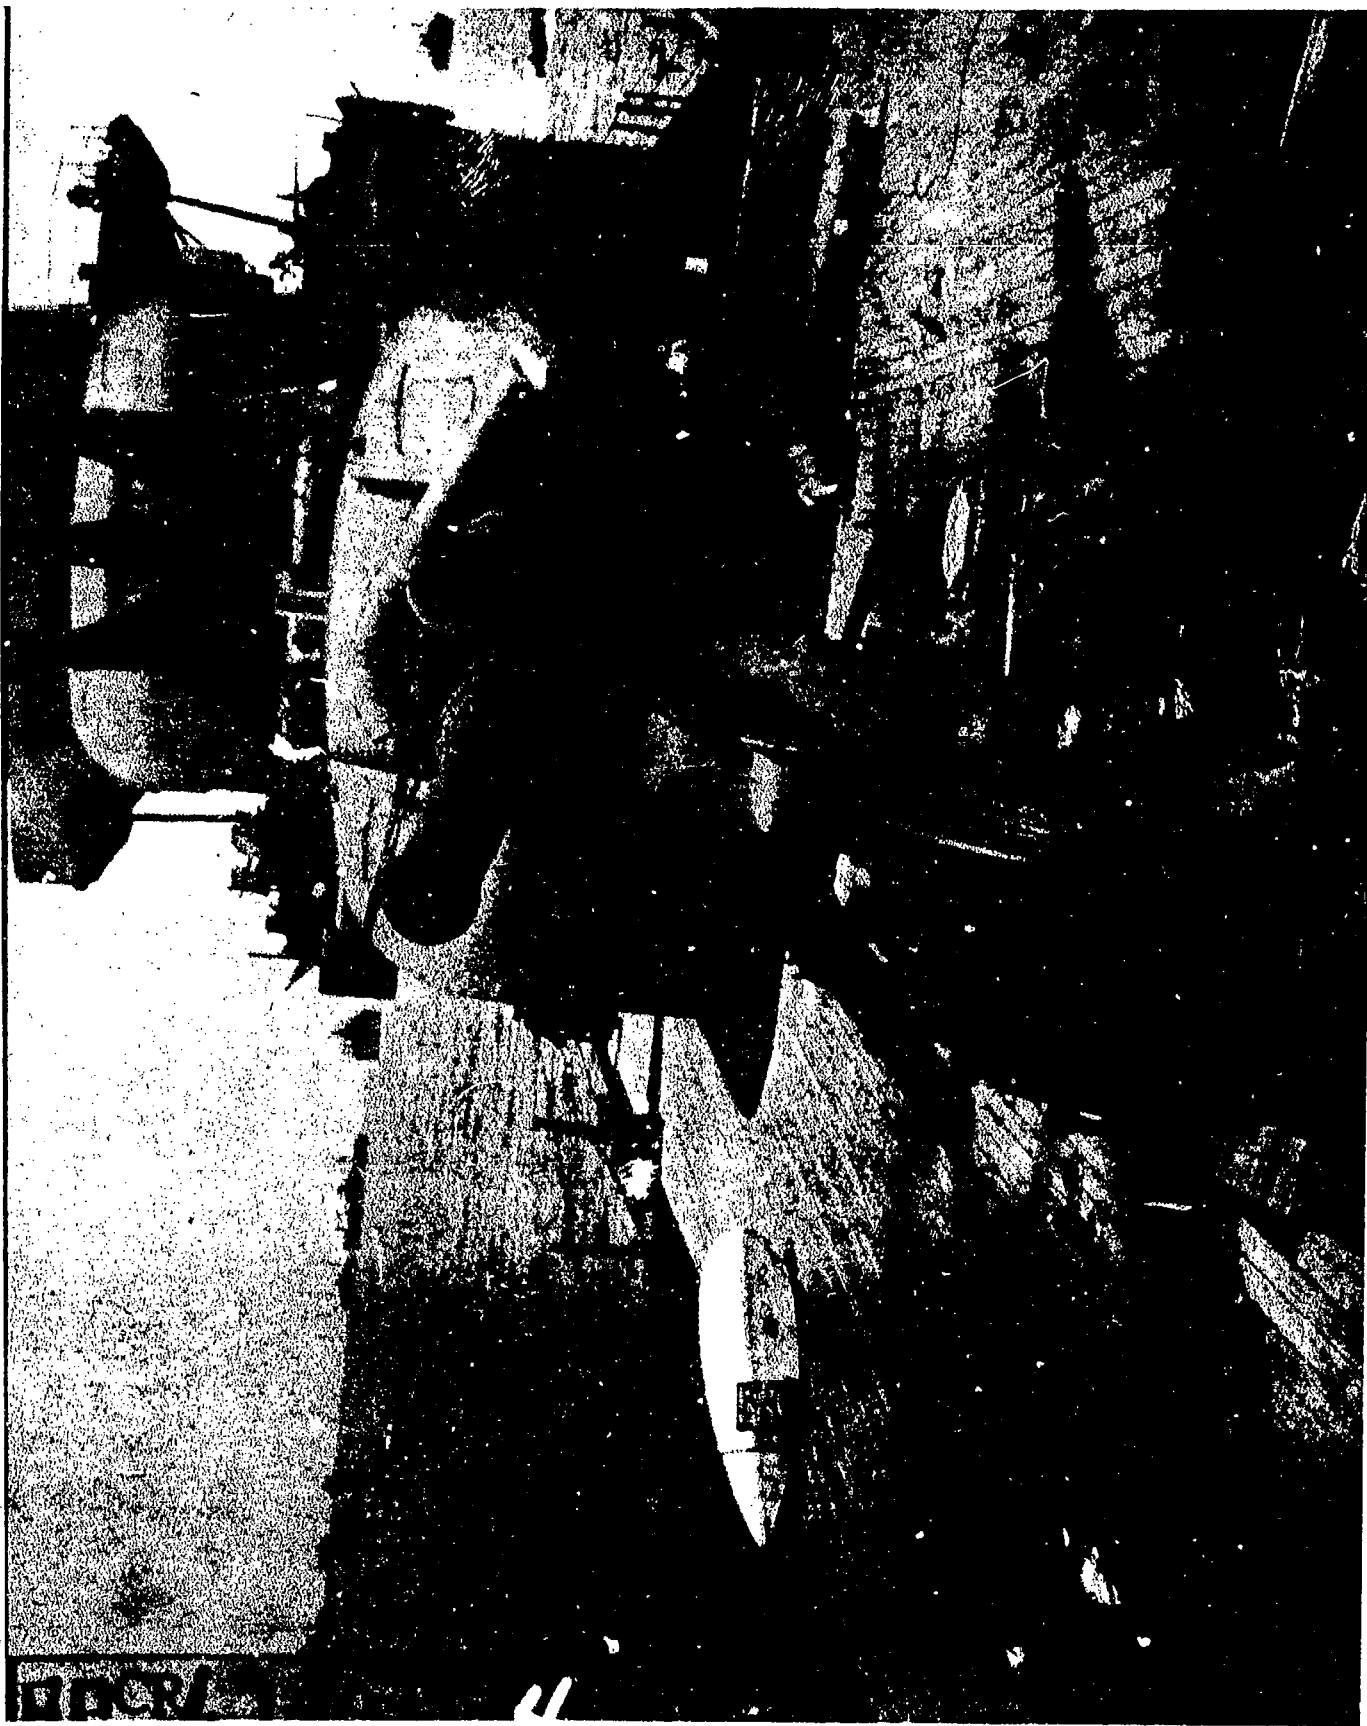
AA-CR-62-1861-4. Looking aft on forecastle showing airplane wing float and part of aileron believed to have come from plane at frame 65, starboard. Note broken life raft.

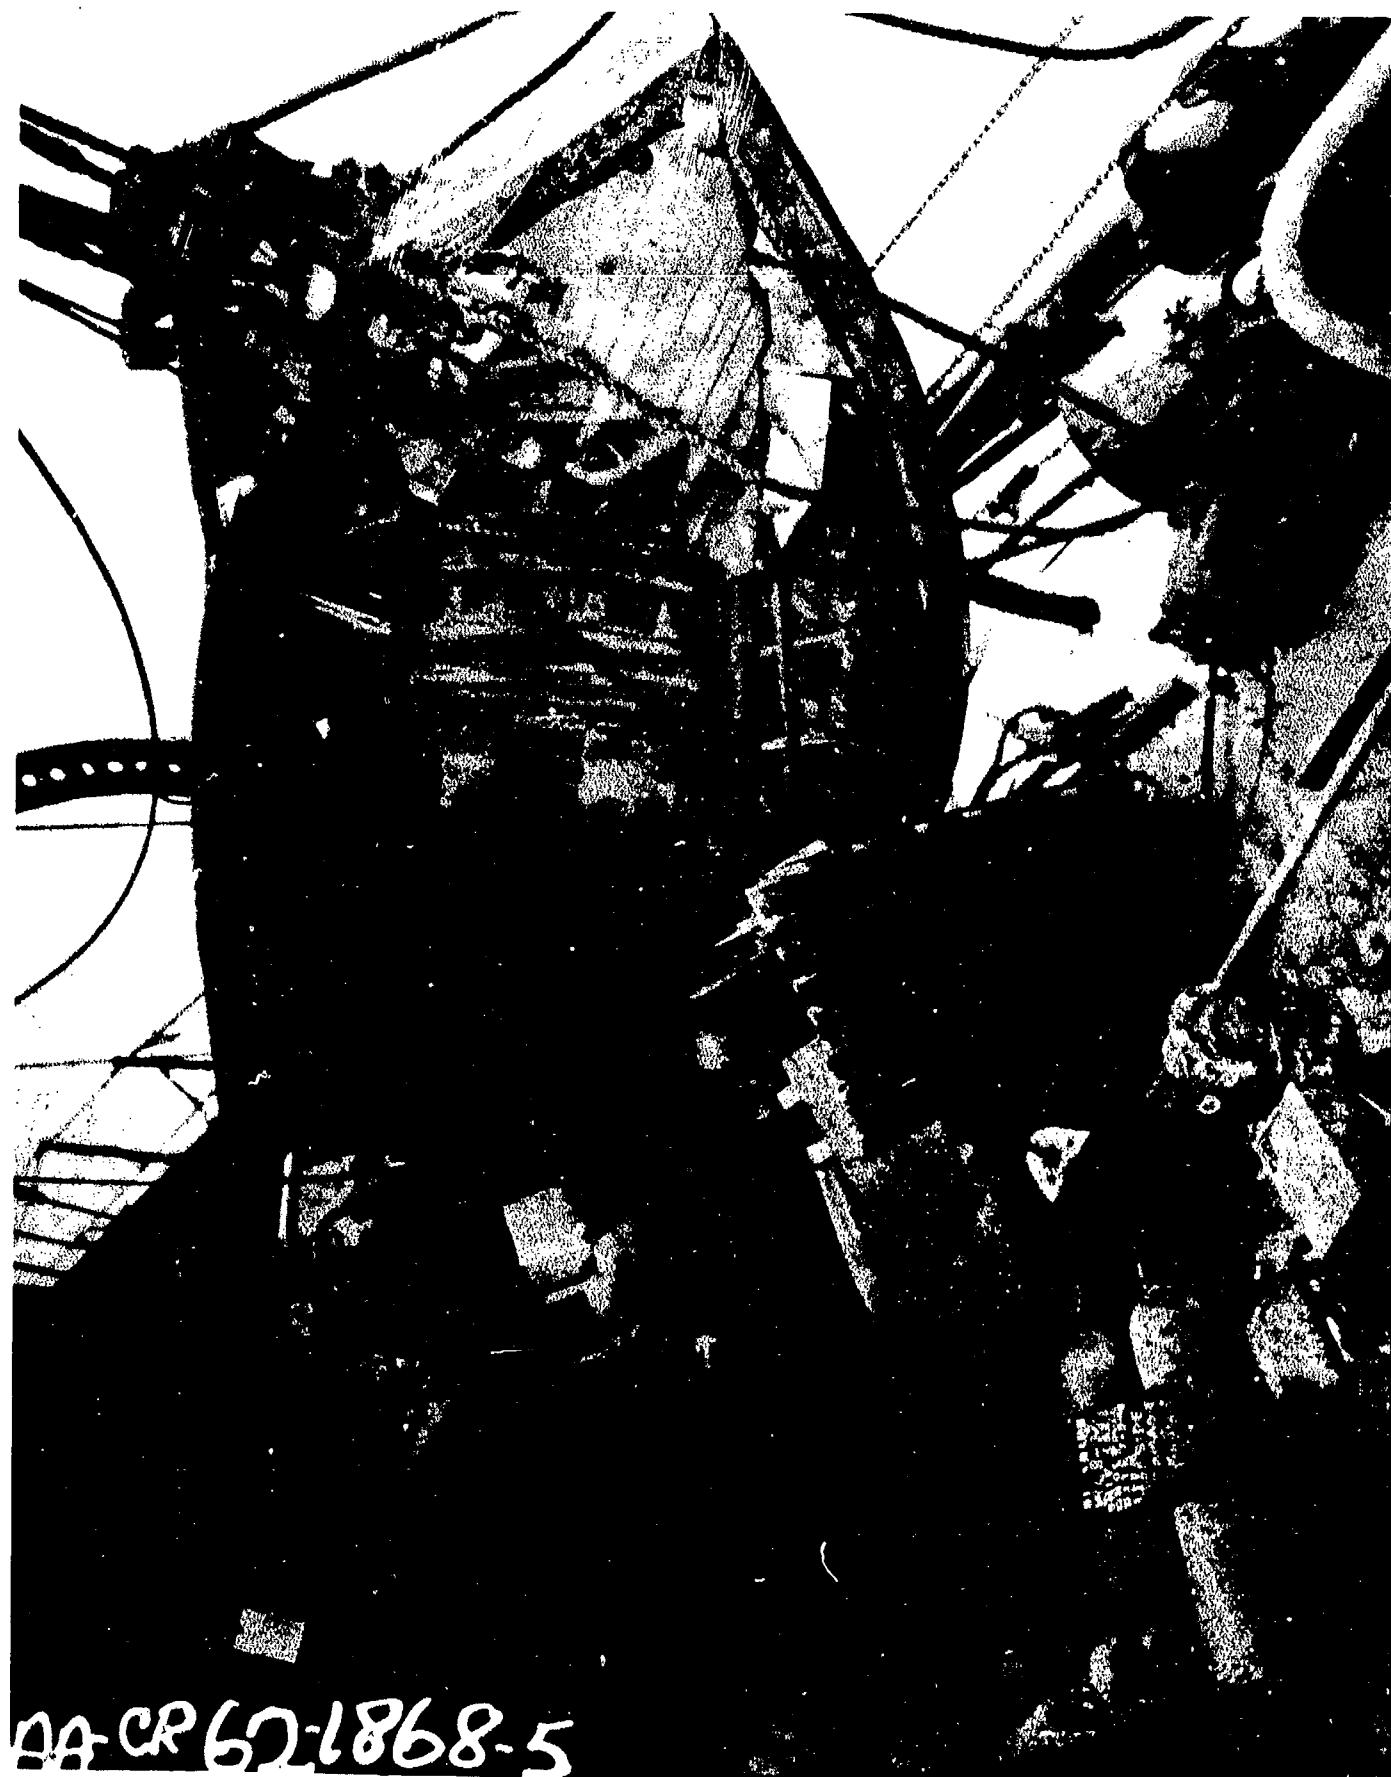
AA-CR-62-1868-5

AA-CR-62-1868-5. Looking down on boat stowage, main deck frame 93 to 100, port.

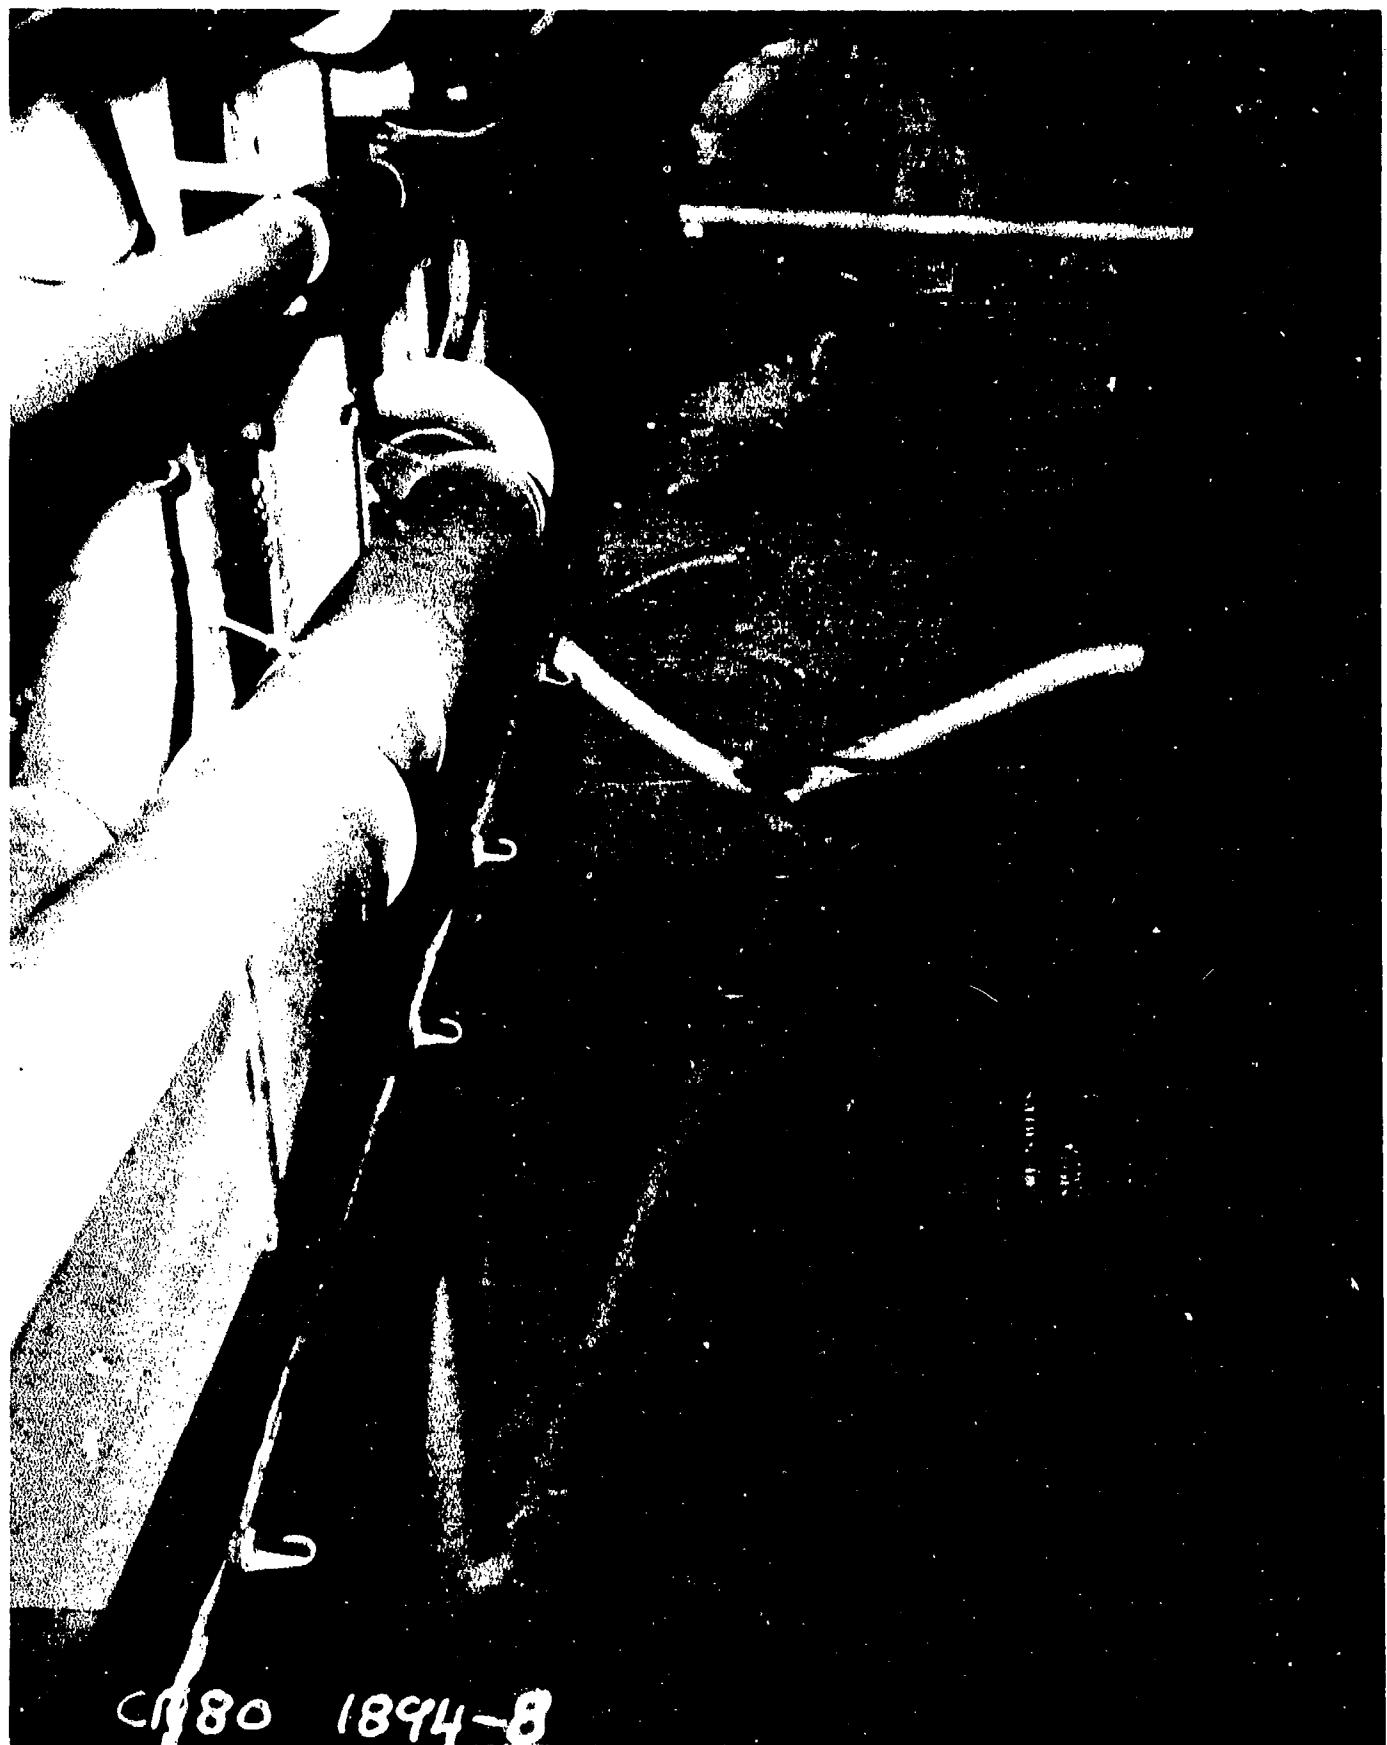
AA-CR-80-1894-8. C-201L. Looking forward and to starboard from frame 70, port. Showing interior damaged caused by deflection of main deck. Note hot waterline sagging.

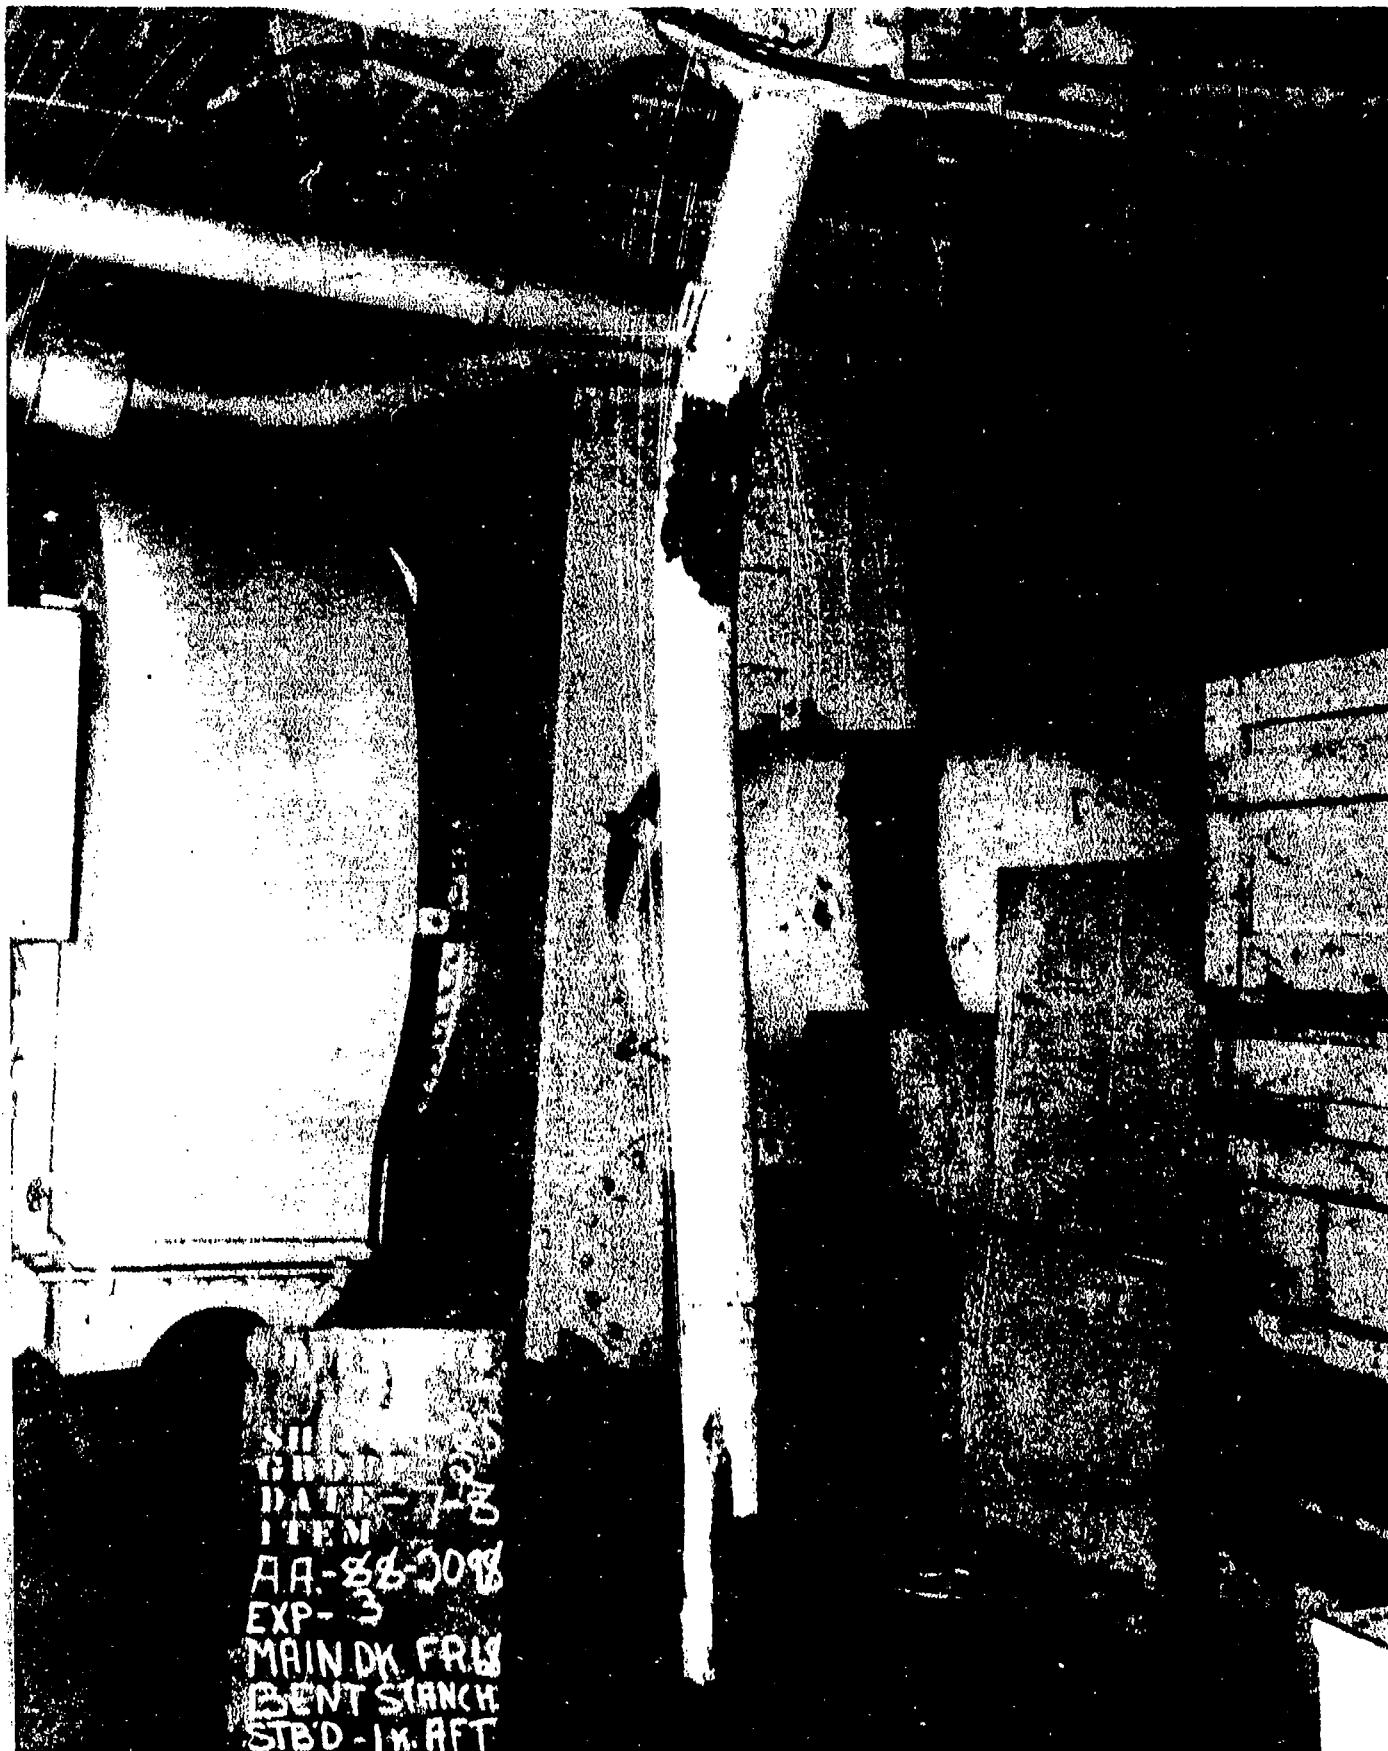
AA-CR-88-2098-3. C-201L. Looking aft at bent stanchion under main deck at frame 68, starboard.

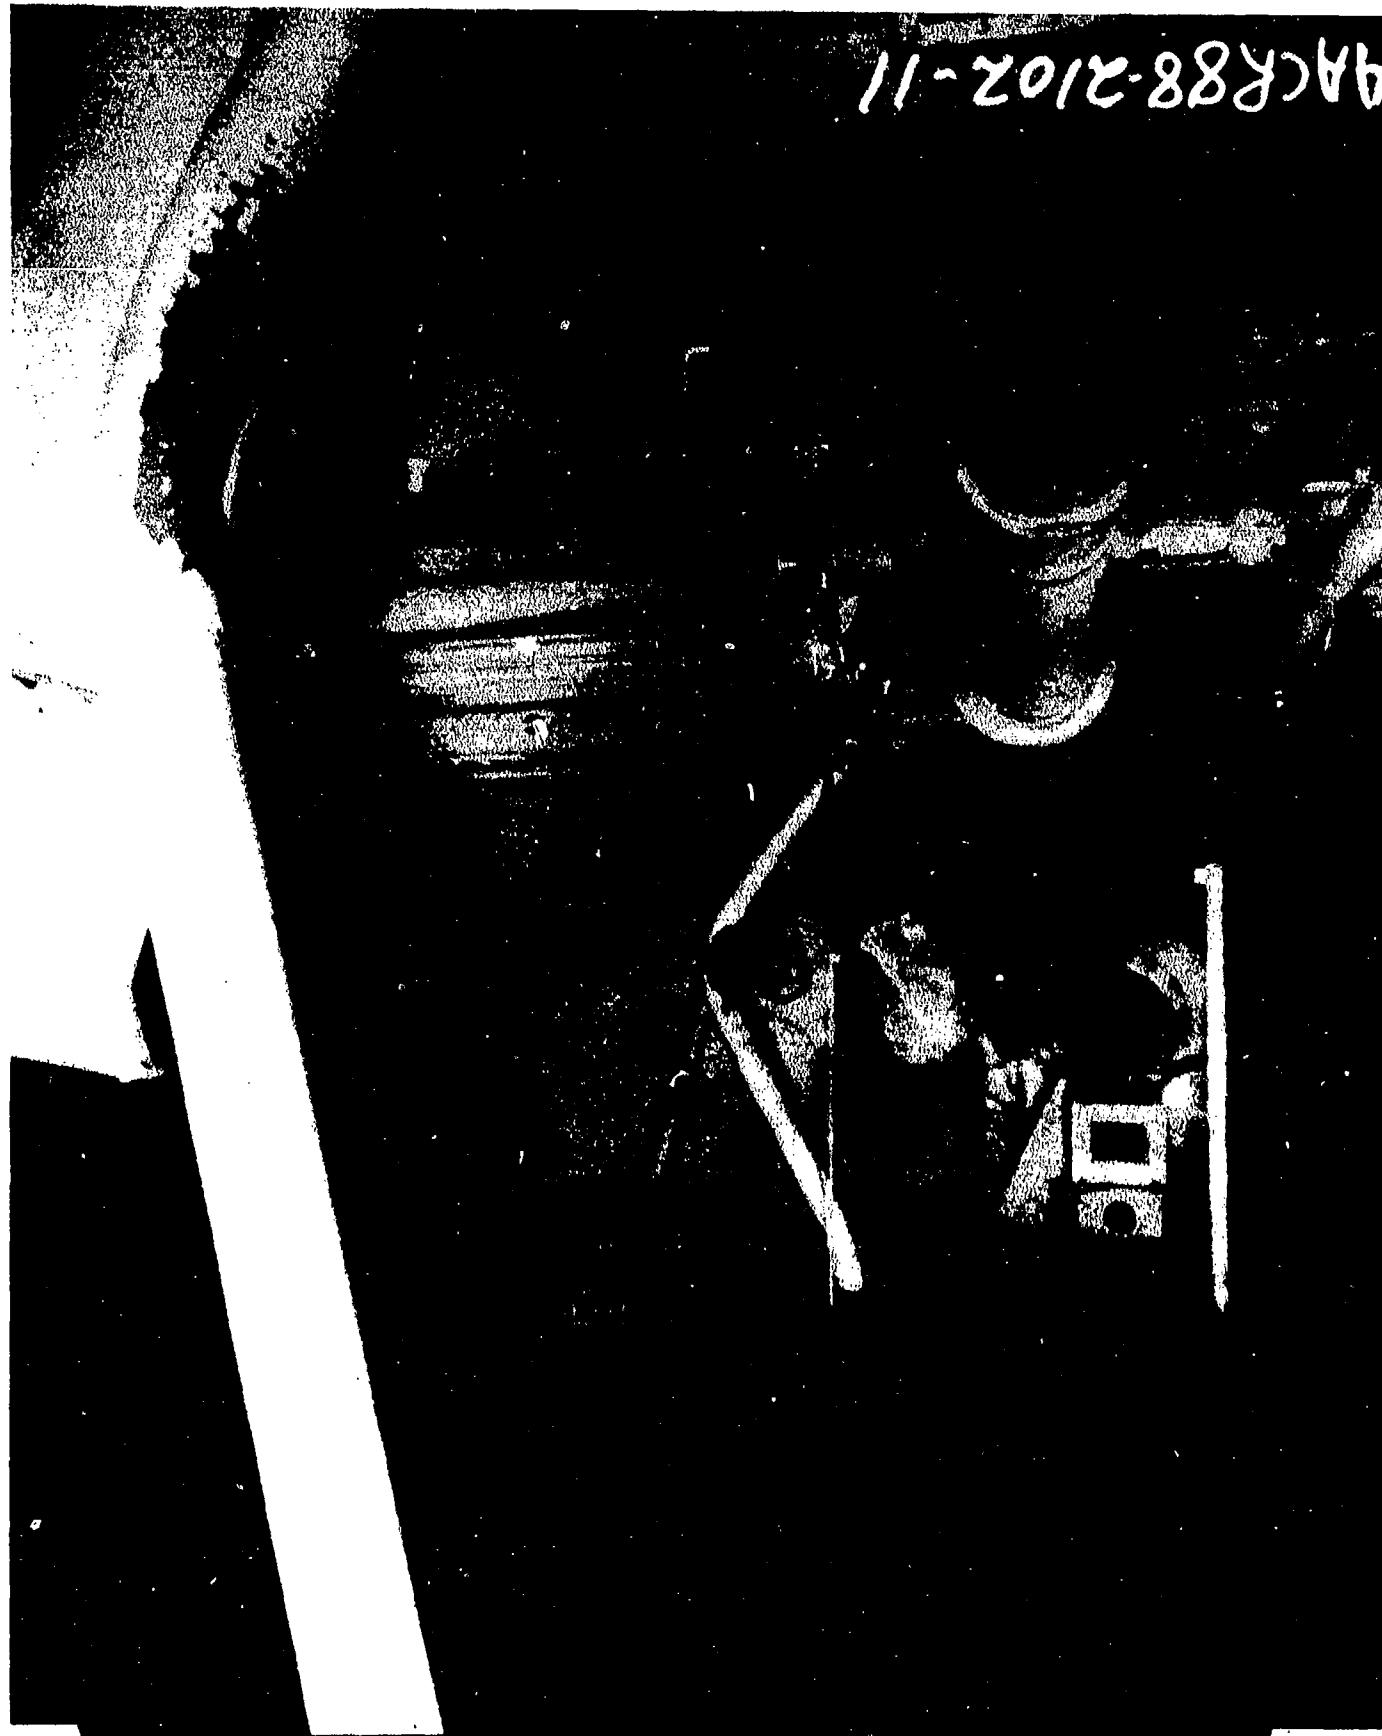
AA-CR-88-2102-11. C-201-L. Looking to starboard at distortion of transverse frame 68 and supporting stanchion.

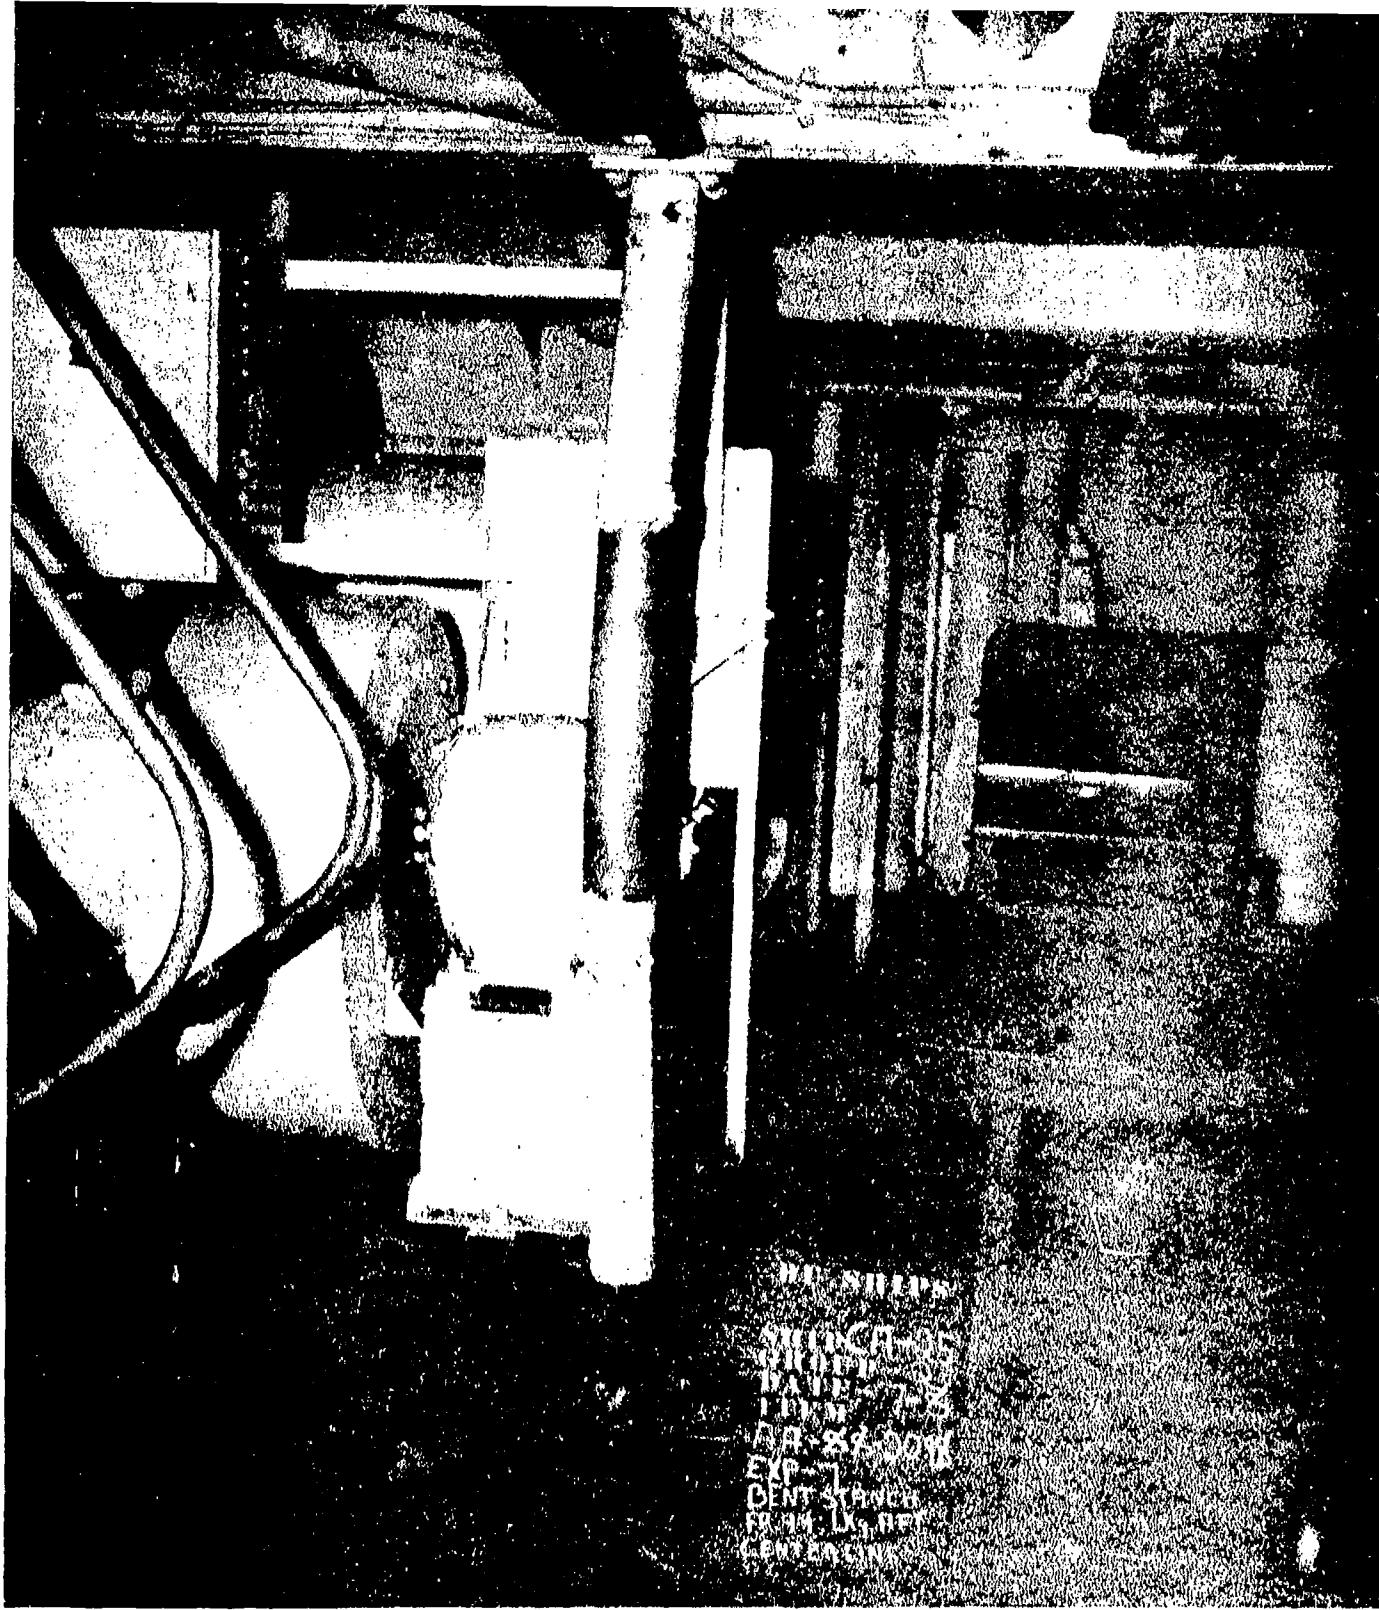
AA-CR-88-2098-7. C-202L. Looking aft at bent centerline stanchion,
frame 94.
